Comer Homes Group

North London Business Park

Phase 2 Geo-environmental and Geotechnical Site
Investigation

1921321-R01(00)

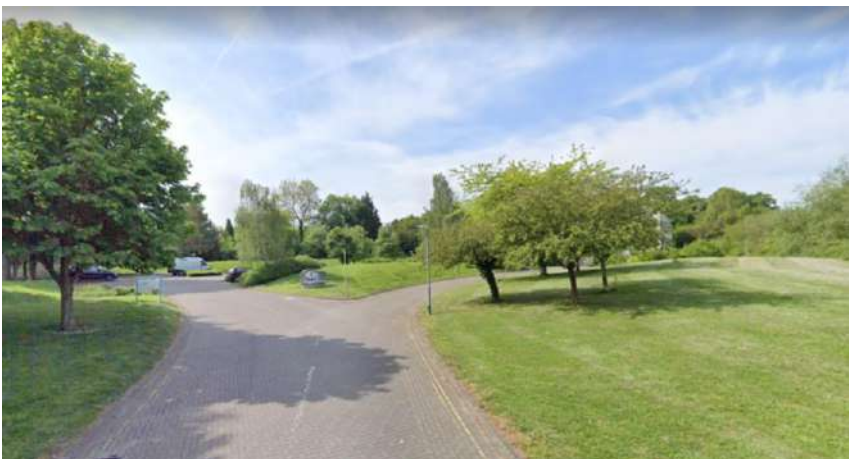
Photo No. 4	Date: May 2019

Description: Bunded areas of soft landscaping located adjacent to paved roadway in the eastern part of site. Image taken viewing south. Image Source: Google Street View (2020)

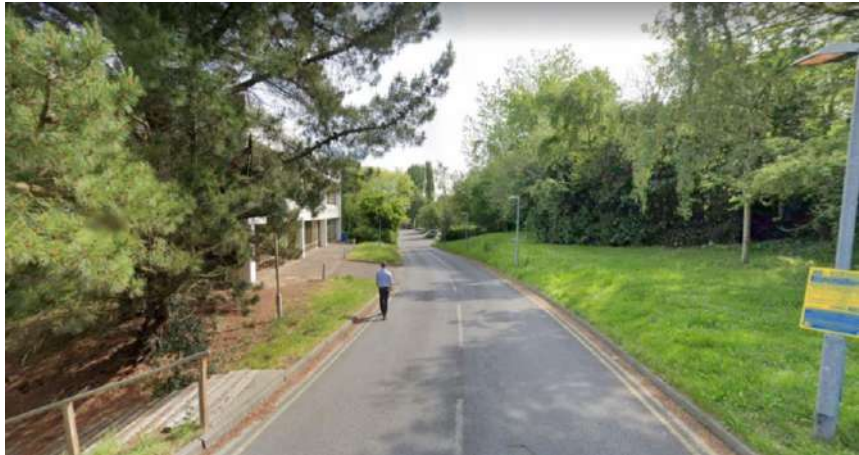
Photo No. 6	Date: May 2019

Description: Bunded soft landscaping along the southern boundary of site. Image taken viewing east within south western corner of site. Image Source: Google Street View (2020)

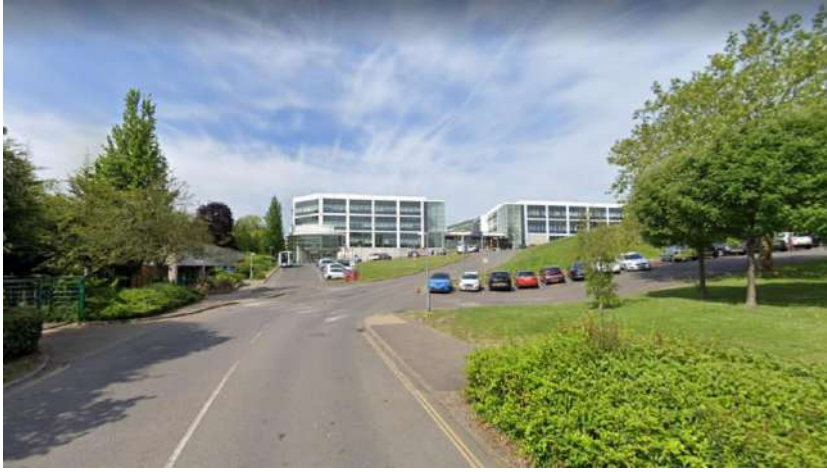
Photo No. 8	Date: May 2019

Description: Main commercial buildings of business park and increase of elevation towards the west. Image taken viewing west. Image Source: Google Street View (2020)

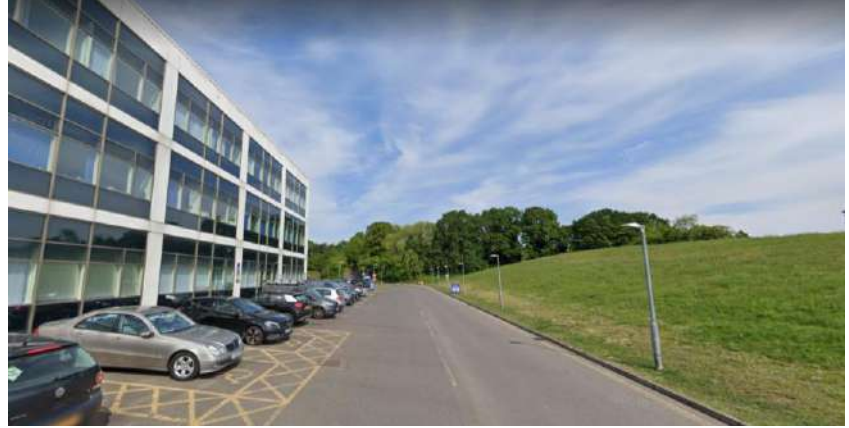
Photo No. 12	Date: May 2019

Description: Western boundary of site, image taken viewing north. Business centre positioned left with large banded soft landscaping towards the right. Image Source: Google Street View (2020)

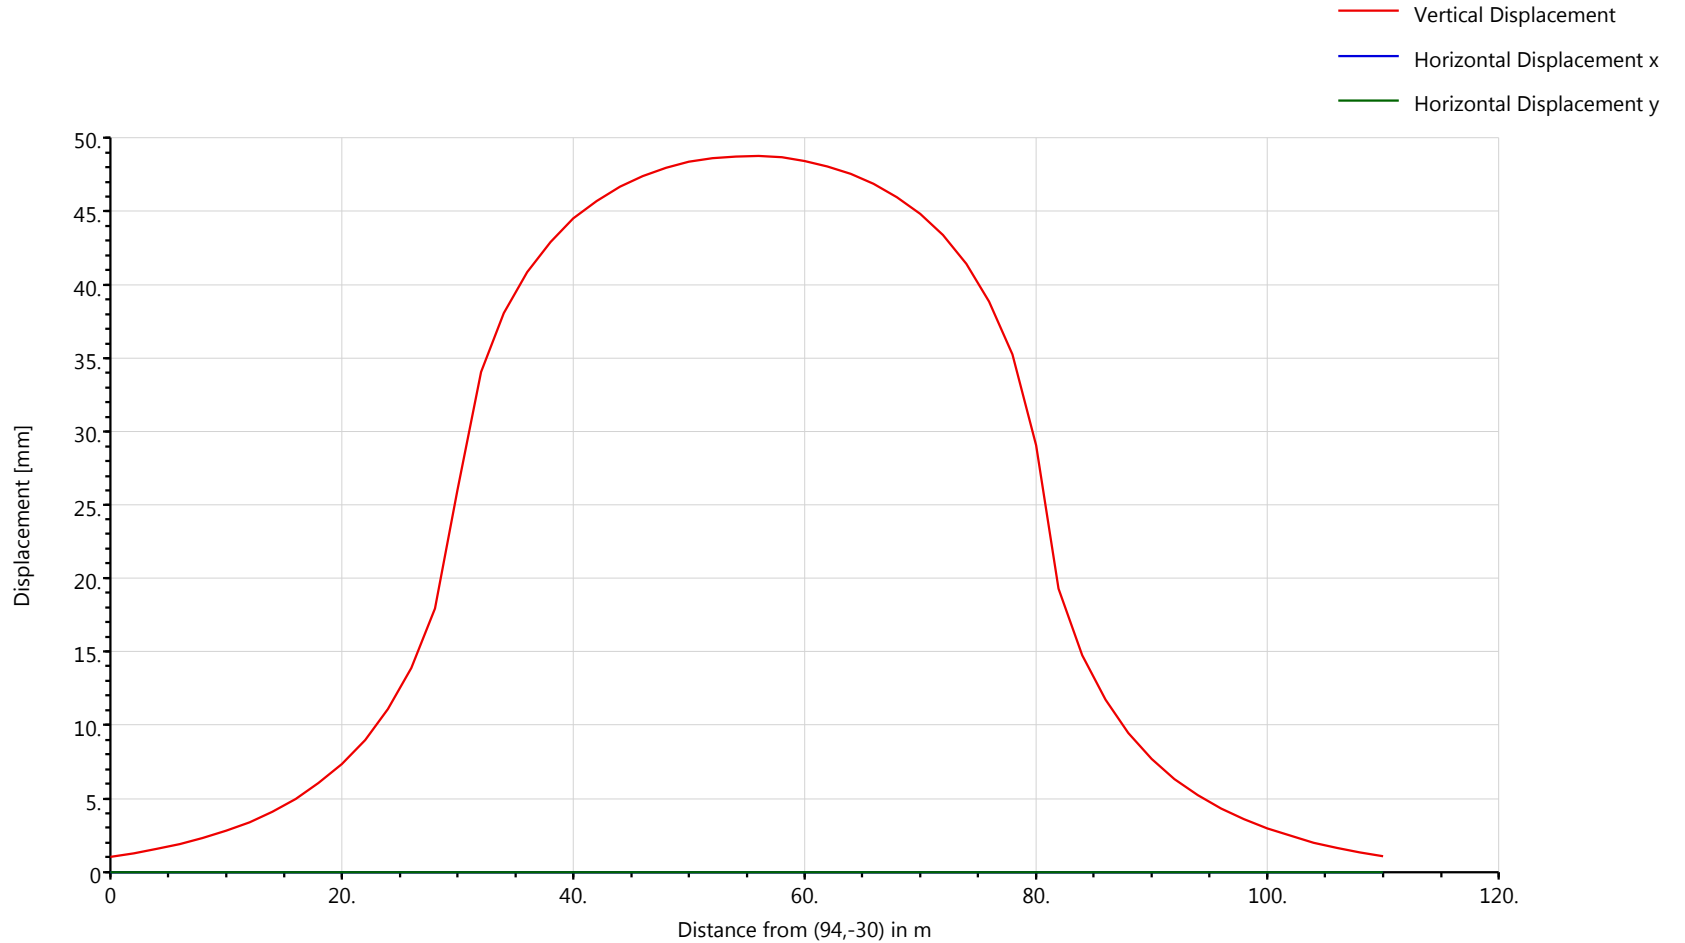
Displacement for Displacement Line 4
